Informational Summary Report of Serious CAL FIRE Injuries, Illnesses, Accidents and Near-Miss Incidents

Jesusita Fire Burnover

Firefighter Burn Injuries with Engine Burnover, and Additional Related Near Miss Incidents

**CA-LPF-001479 – P5EV5C
CA-CSR-000031**

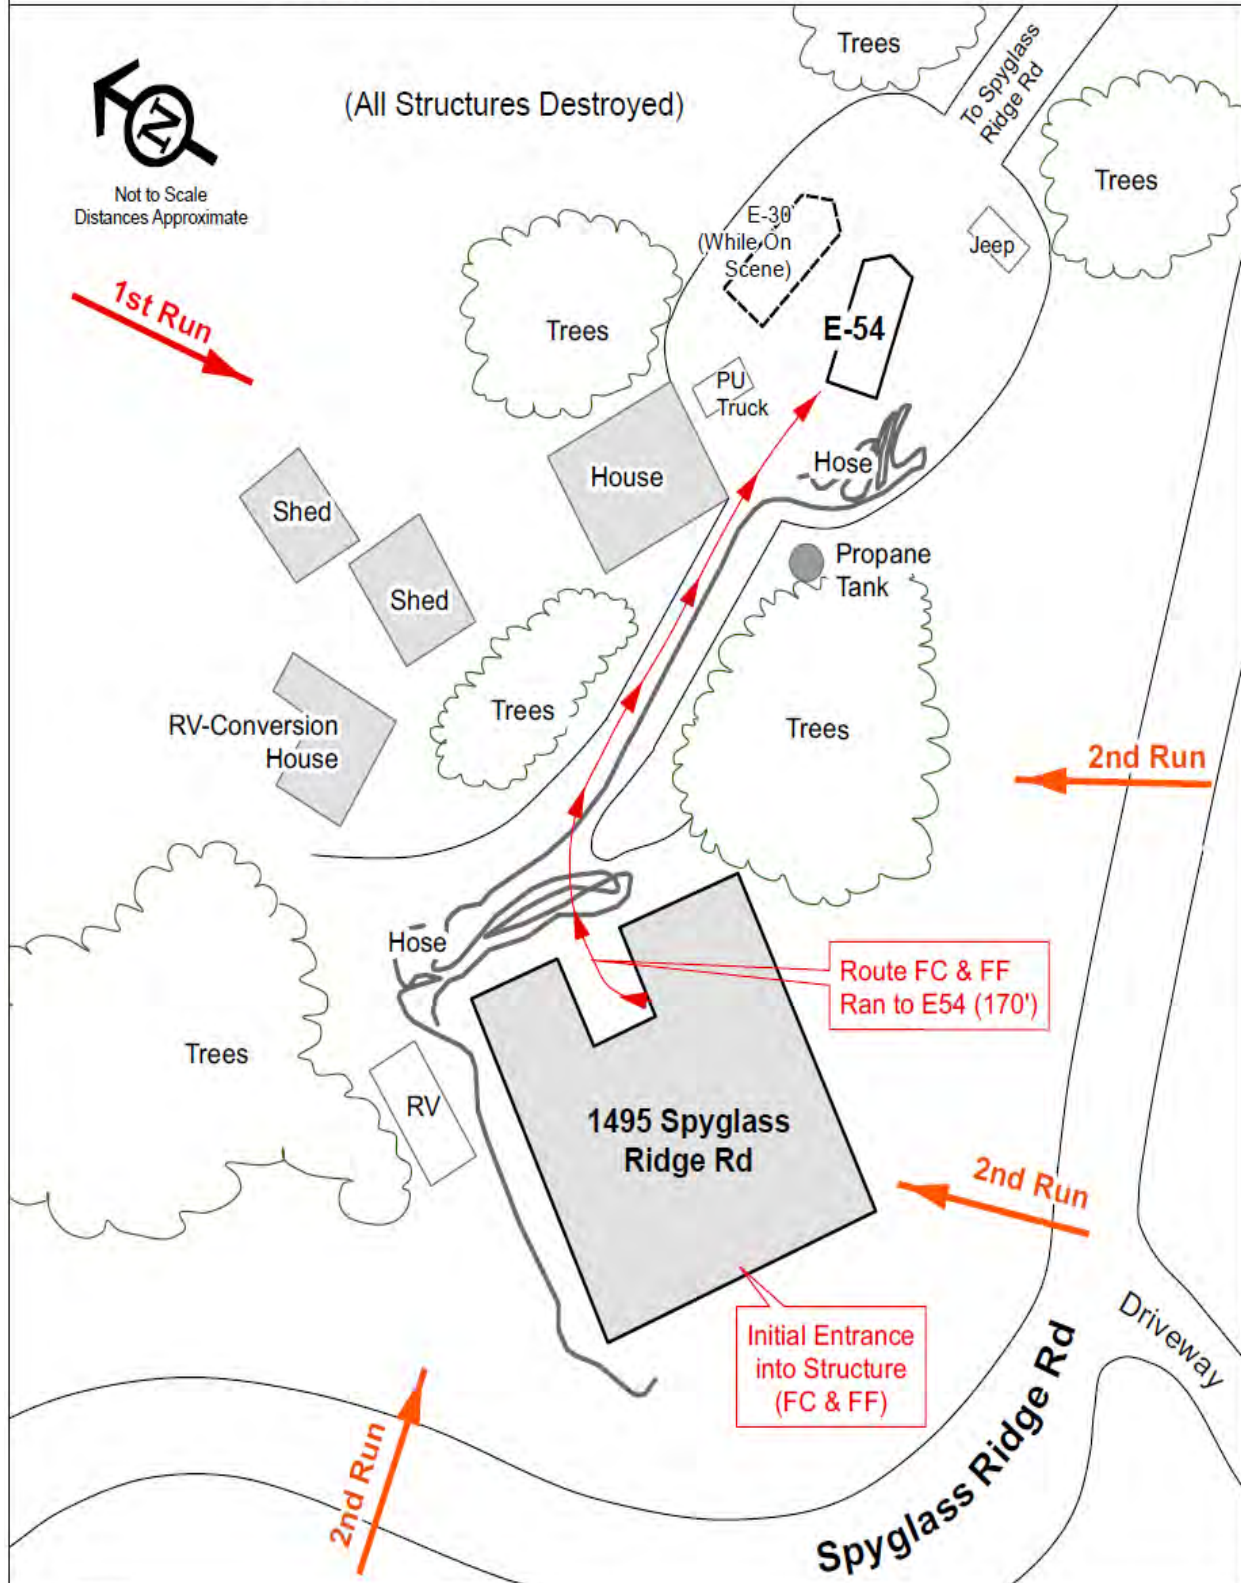
1495 Spyglass Ridge Rd

At approximately 4:00 p.m. the fire made extreme advances towards the Spyglass Ridge Road area. Numerous spot fires caused a condition similar to area ignition around 1495 Spyglass Ridge Road. FC-54 told FF-54 to protect the rear of the main structure. After several minutes of firefighting, FC-54 took FF-54 into the structure, entering through the back door on the Southwest side to wait for the fire to pass. While inside the structure, FF-54 removed his web gear and fire shelter and donned his SCBA. FC-54 also donned his SCBA over his web gear and fire shelter.

As FC-54 and FF-54 exited the structure, FC-54 instantly felt his skin burning. FF-54 fell to the ground as FC-54 ran up the driveway towards E-54. FC-54 thought that FF-54 was attempting to deploy the fire shelter at that location. FC-54 yelled at FF-54 to continue to the fire engine. FC-54 arrived at the fire engine and climbed into the back seat on the passenger side still wearing his SCBA. FC-54 could not locate FF-54 and his low air warning device was sounding on his SCBA.

- VNC E-54 had severe fire damage to the front and left side of the apparatus. The hose bed had major damage from the cribbing and hose that caught fire. The apparatus had a transmission leak along the left frame rail, but was physically driven off the mountain.
- VNC E-30 received minor exterior heat/fire damage.

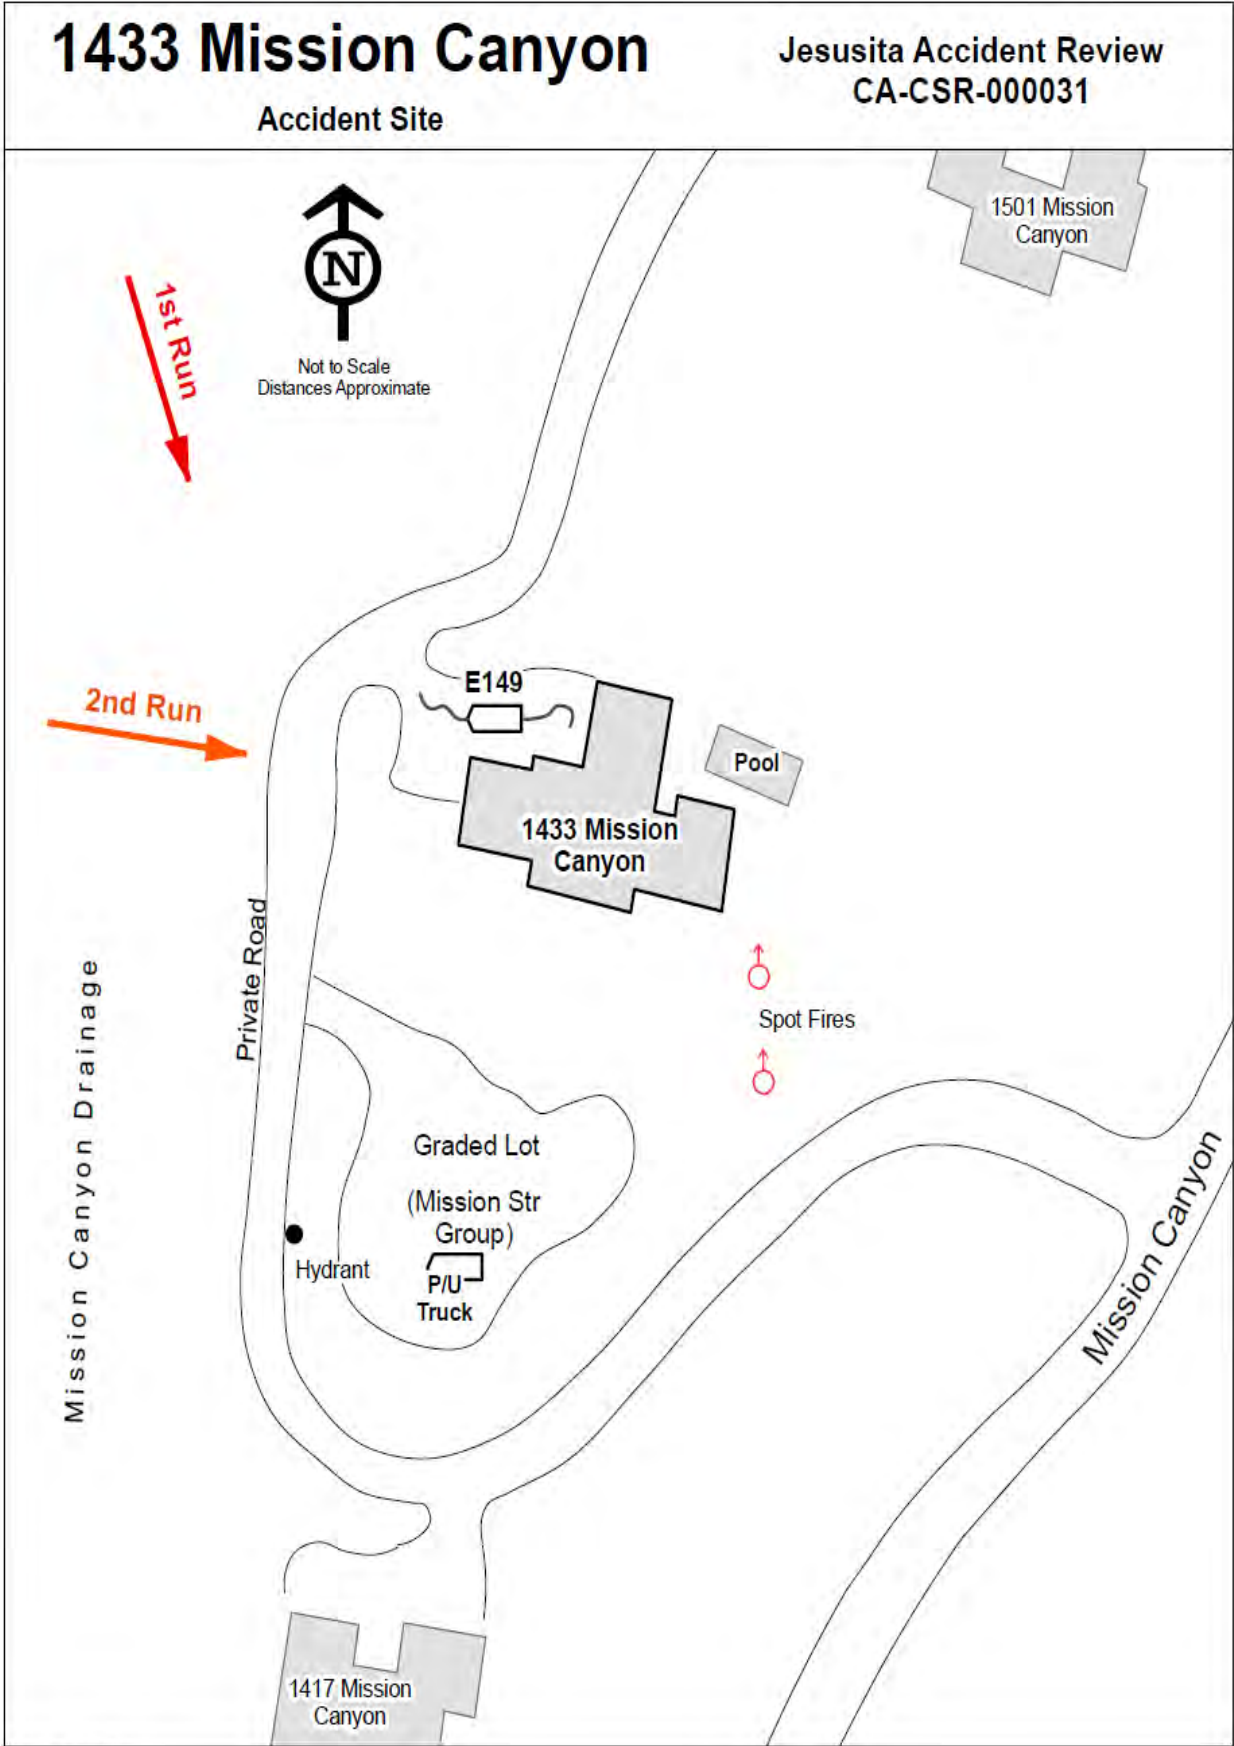
(See 1433 Mission Canyon Map attached)

At approximately 3:00 PM the wind transitioned from an upslope southerly direction to a down canyon northerly direction and increased substantially. The head fire made a run down the Mission Canyon Drainage toward 1433 Mission Canyon Road. Spot fires developed around the structure. At approximately 3:40 PM conditions deteriorated more than anticipated. At approximately 3:55 PM, due to strong winds, intense heat and poor visibility, FC-149 called for the crew to retreat into the structure. Accountability was conducted and STEN-1241A was notified via radio.

LAC E-149 had the ladder cover with heat/fire damage.

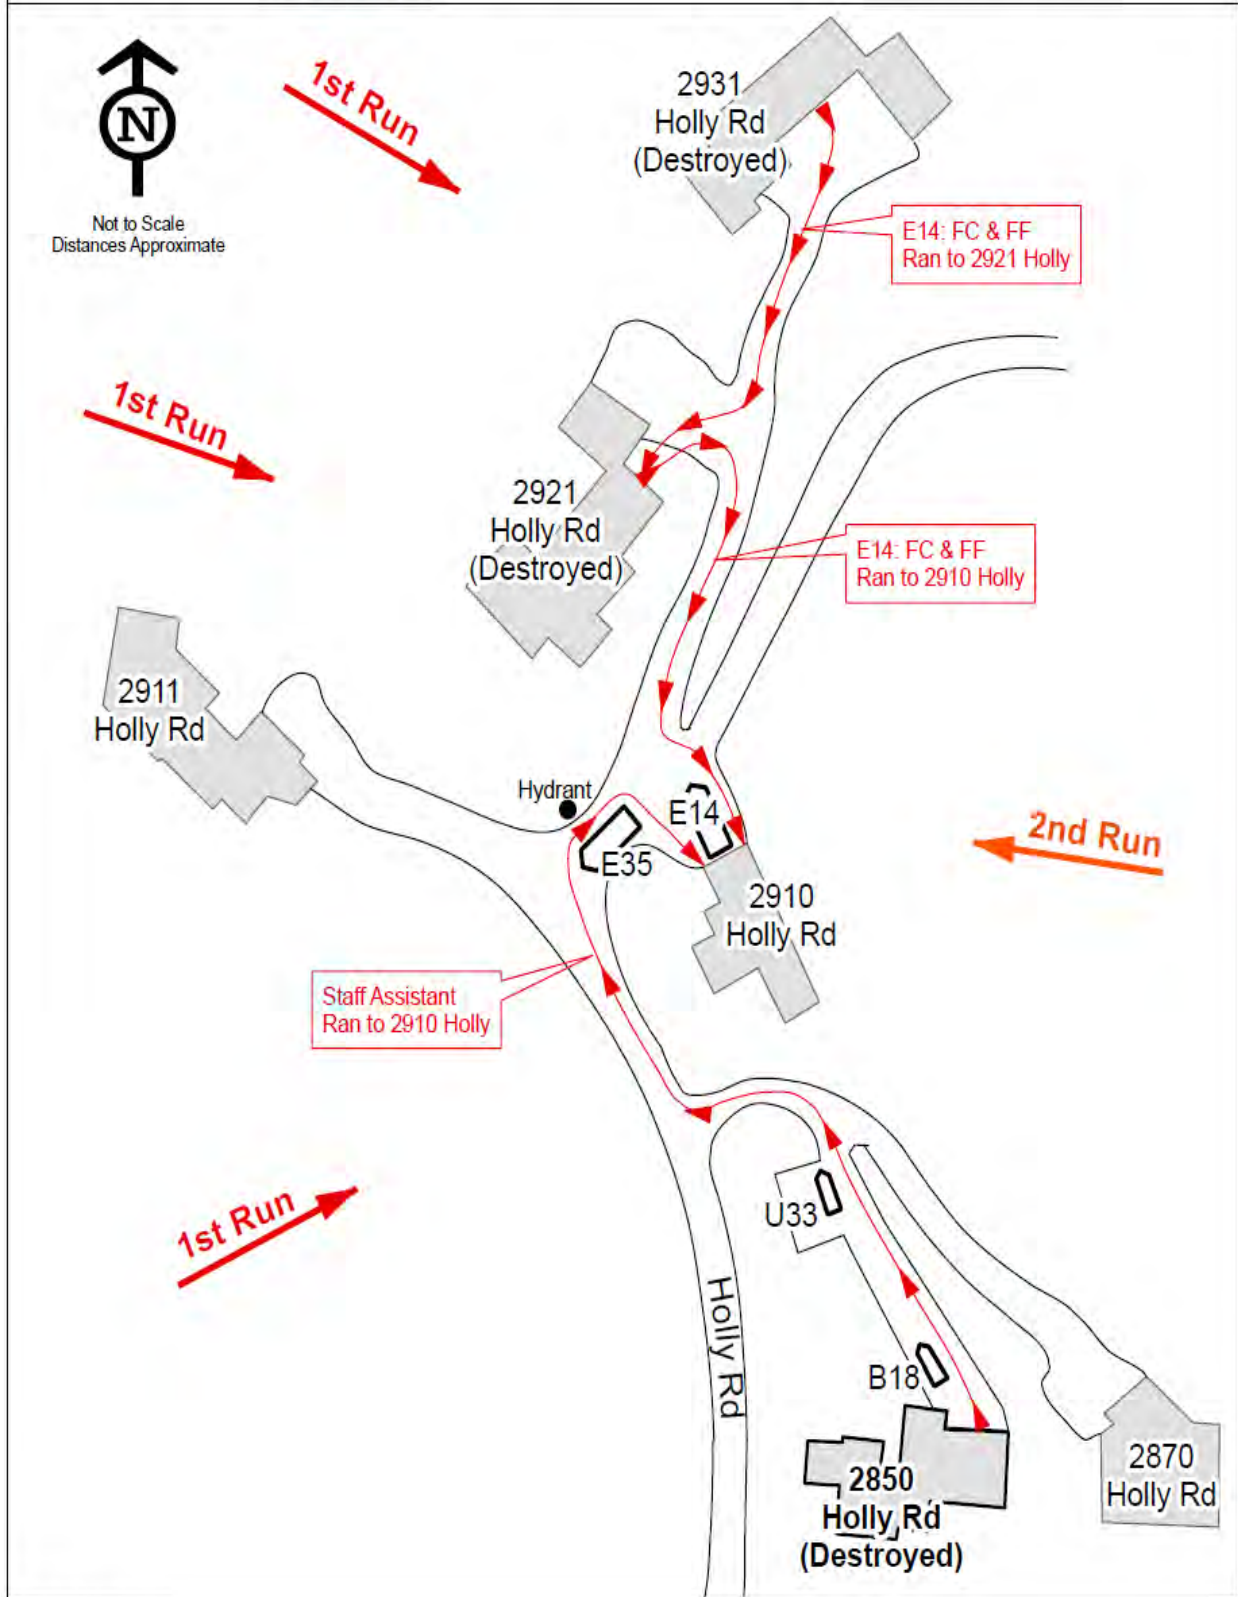
2850 Holly Rd

STEN-1001A immediately gave the order to take refuge. STEN-1001A, STEN(T)-1001A, FAE-14, one firefighter from E-14, FAE-35, and 5 civilians took refuge in the residence at 2910 Holly Road. FC-35 and two Firefighters from E-35 took refuge in the structure located at 2911 Holly Road as their escape route was blocked. FC-14 and one firefighter from E-14 took refuge in the structure located at 2931 Holly Road. They decided the structure would not withstand the fire, and moved to 2921 Holly Road. They took refuge for approximately 15-20 minutes, and when conditions permitted, made their way to 2910 Holly Road with the other personnel.

- LFD B-18 was completely destroyed.
- LFD Utility 33 was completely destroyed.

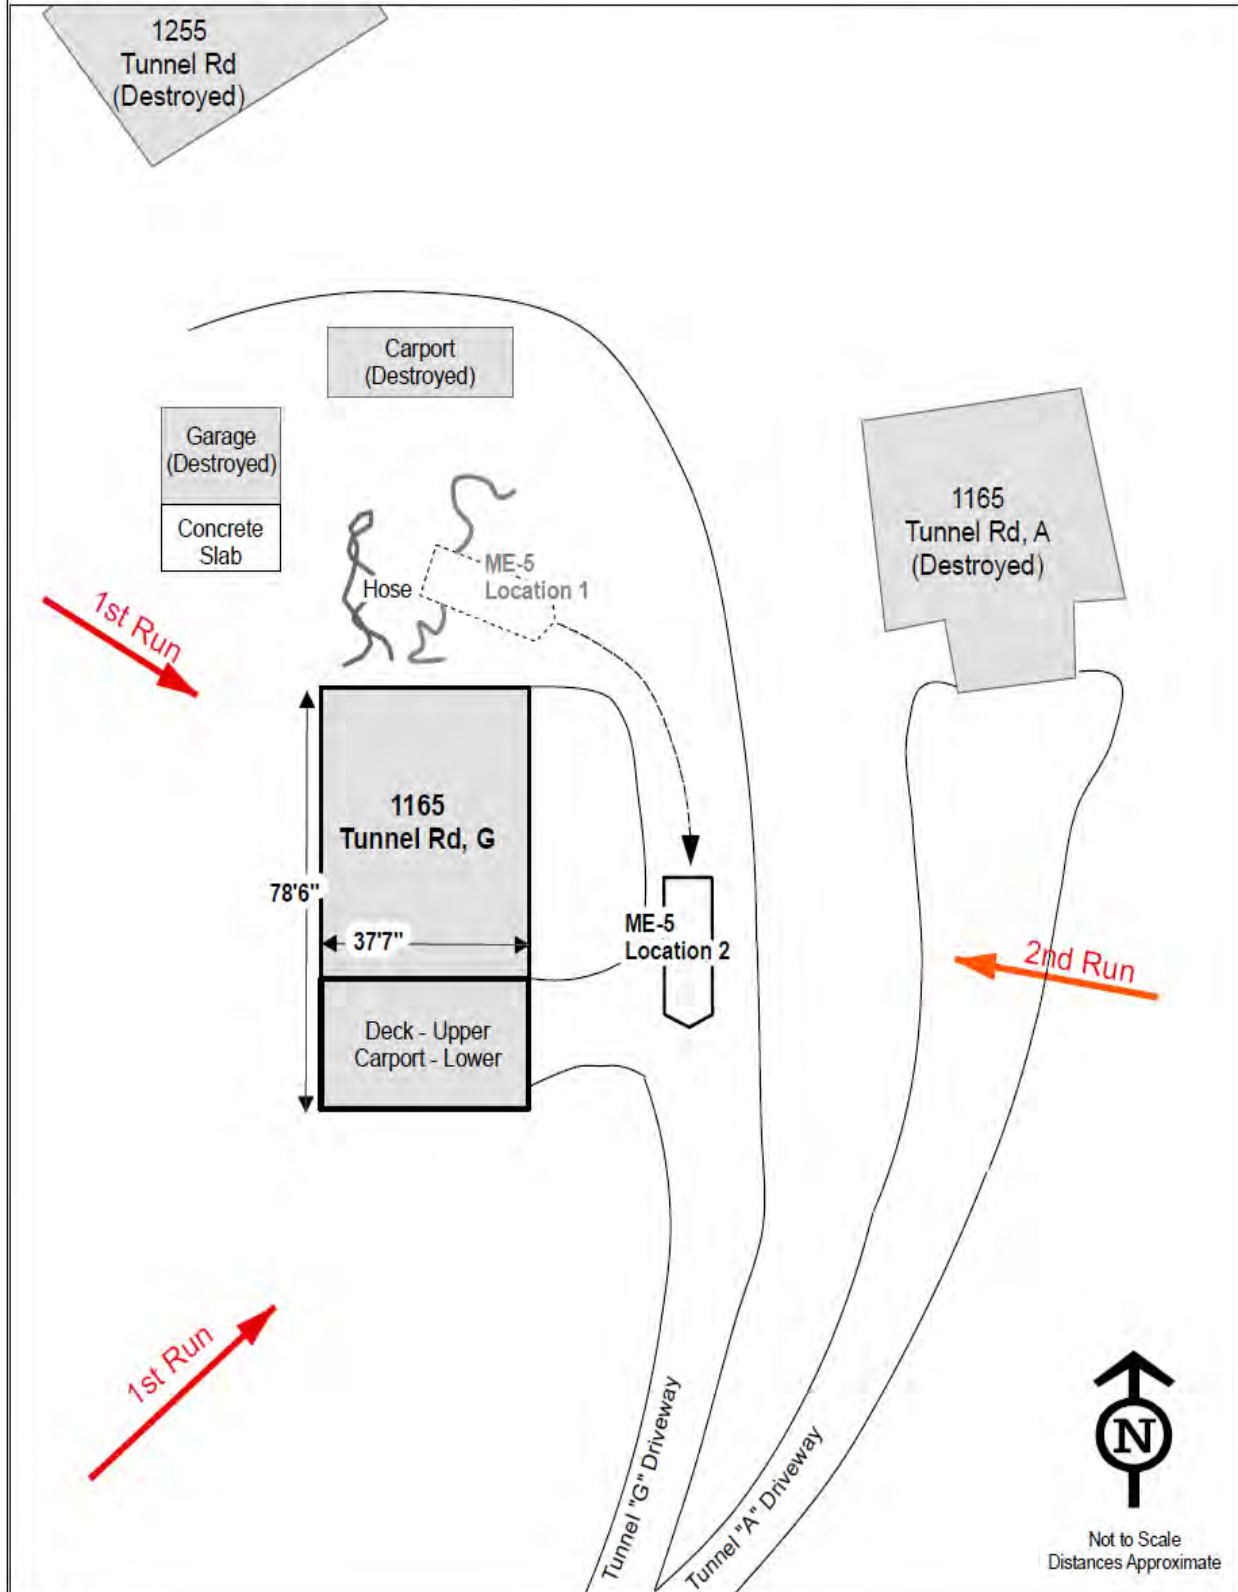
1165 Tunnel Rd, G

Out buildings were destroyed at 1165 Tunnel Road #G. The main structure received minor damage. All structures were destroyed at 1165 Tunnel Road # A and 1255 Tunnel Road.

SPA E-81 received damage to the left rear upper compartment door and the body had scraping damage consistent with striking a concrete wall. The chrome bezel around the left rear stop, turn signal and back up light assemblies had scrape damage. The engine did not have an ember screen installed in the motor air intake system.
