Informational Summary Report of Serious CAL FIRE Injuries, Illnesses, Accidents and Near-Miss Incidents

Jesusita Fire Burnover

Firefighter Burn Injuries with Engine Burnover, and Additional Related Near Miss Incidents

**CA-LPF-001479 – P5EV5C
CA-CSR-000031**

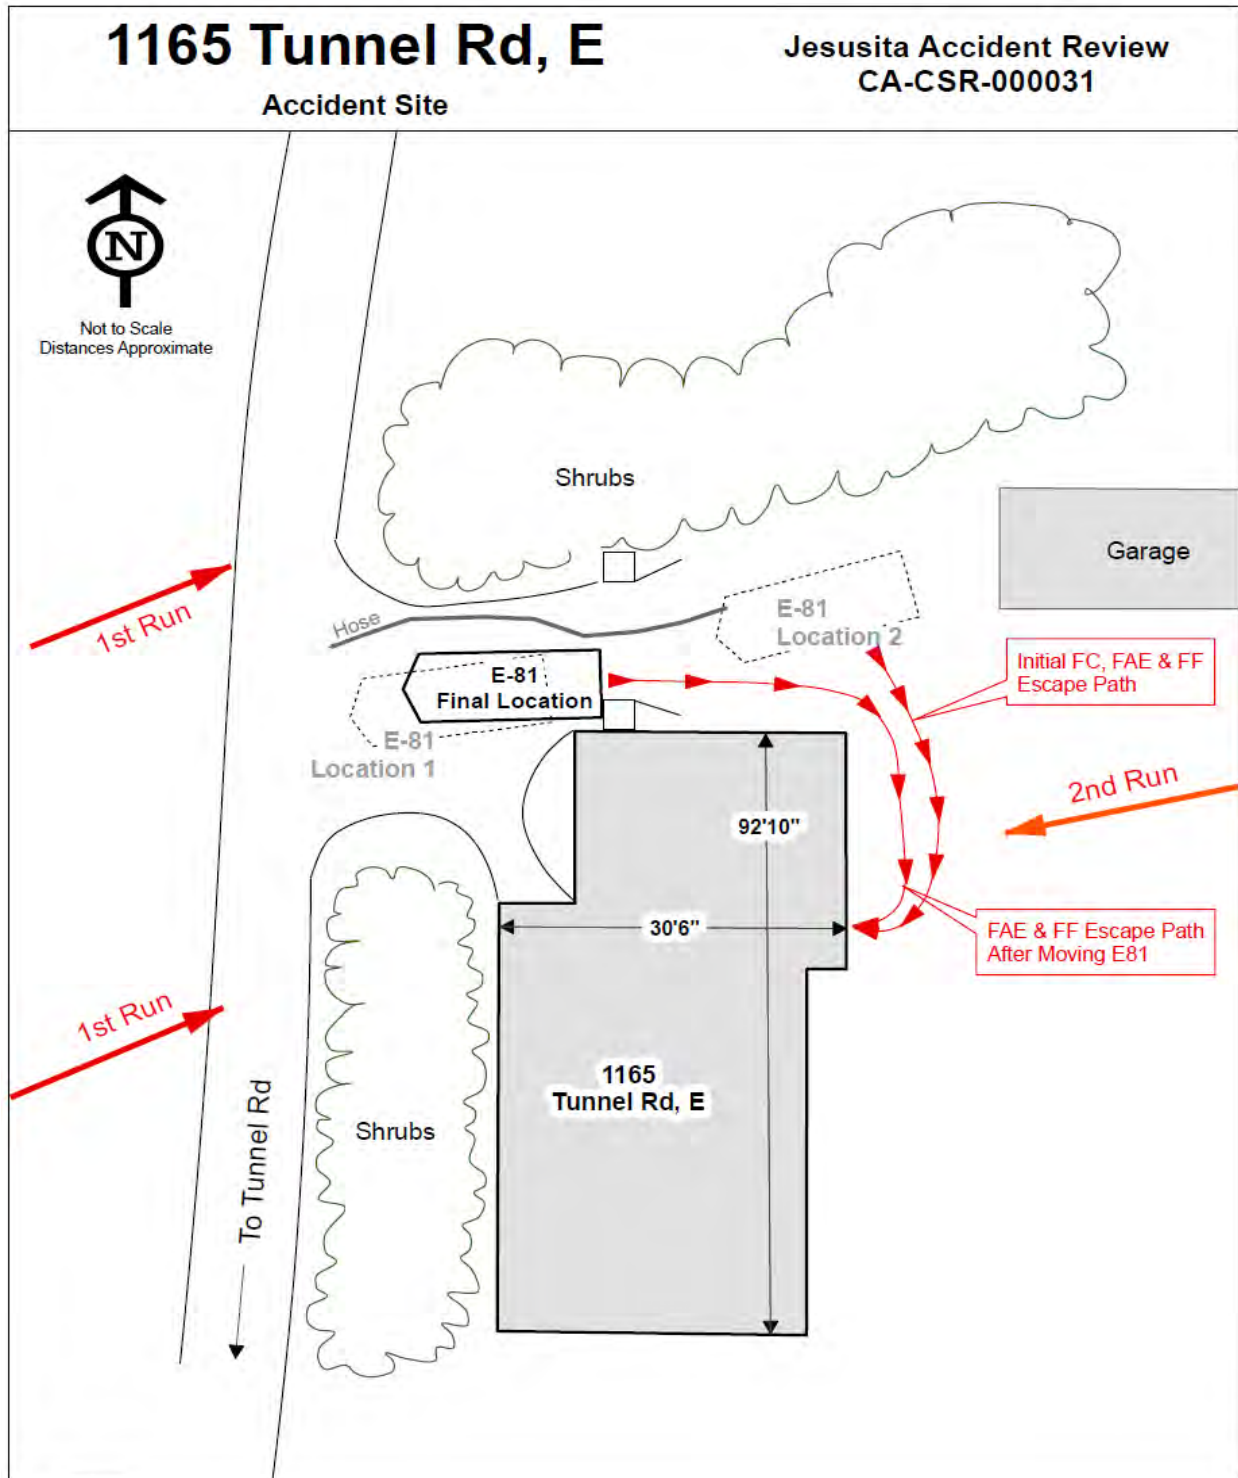
SPA E-81 received damage to the left rear upper compartment door and the body had scraping damage consistent with striking a concrete wall. The chrome bezel around the left rear stop, turn signal and back up light assemblies had scrape damage. The engine did not have an ember screen installed in the motor air intake system.

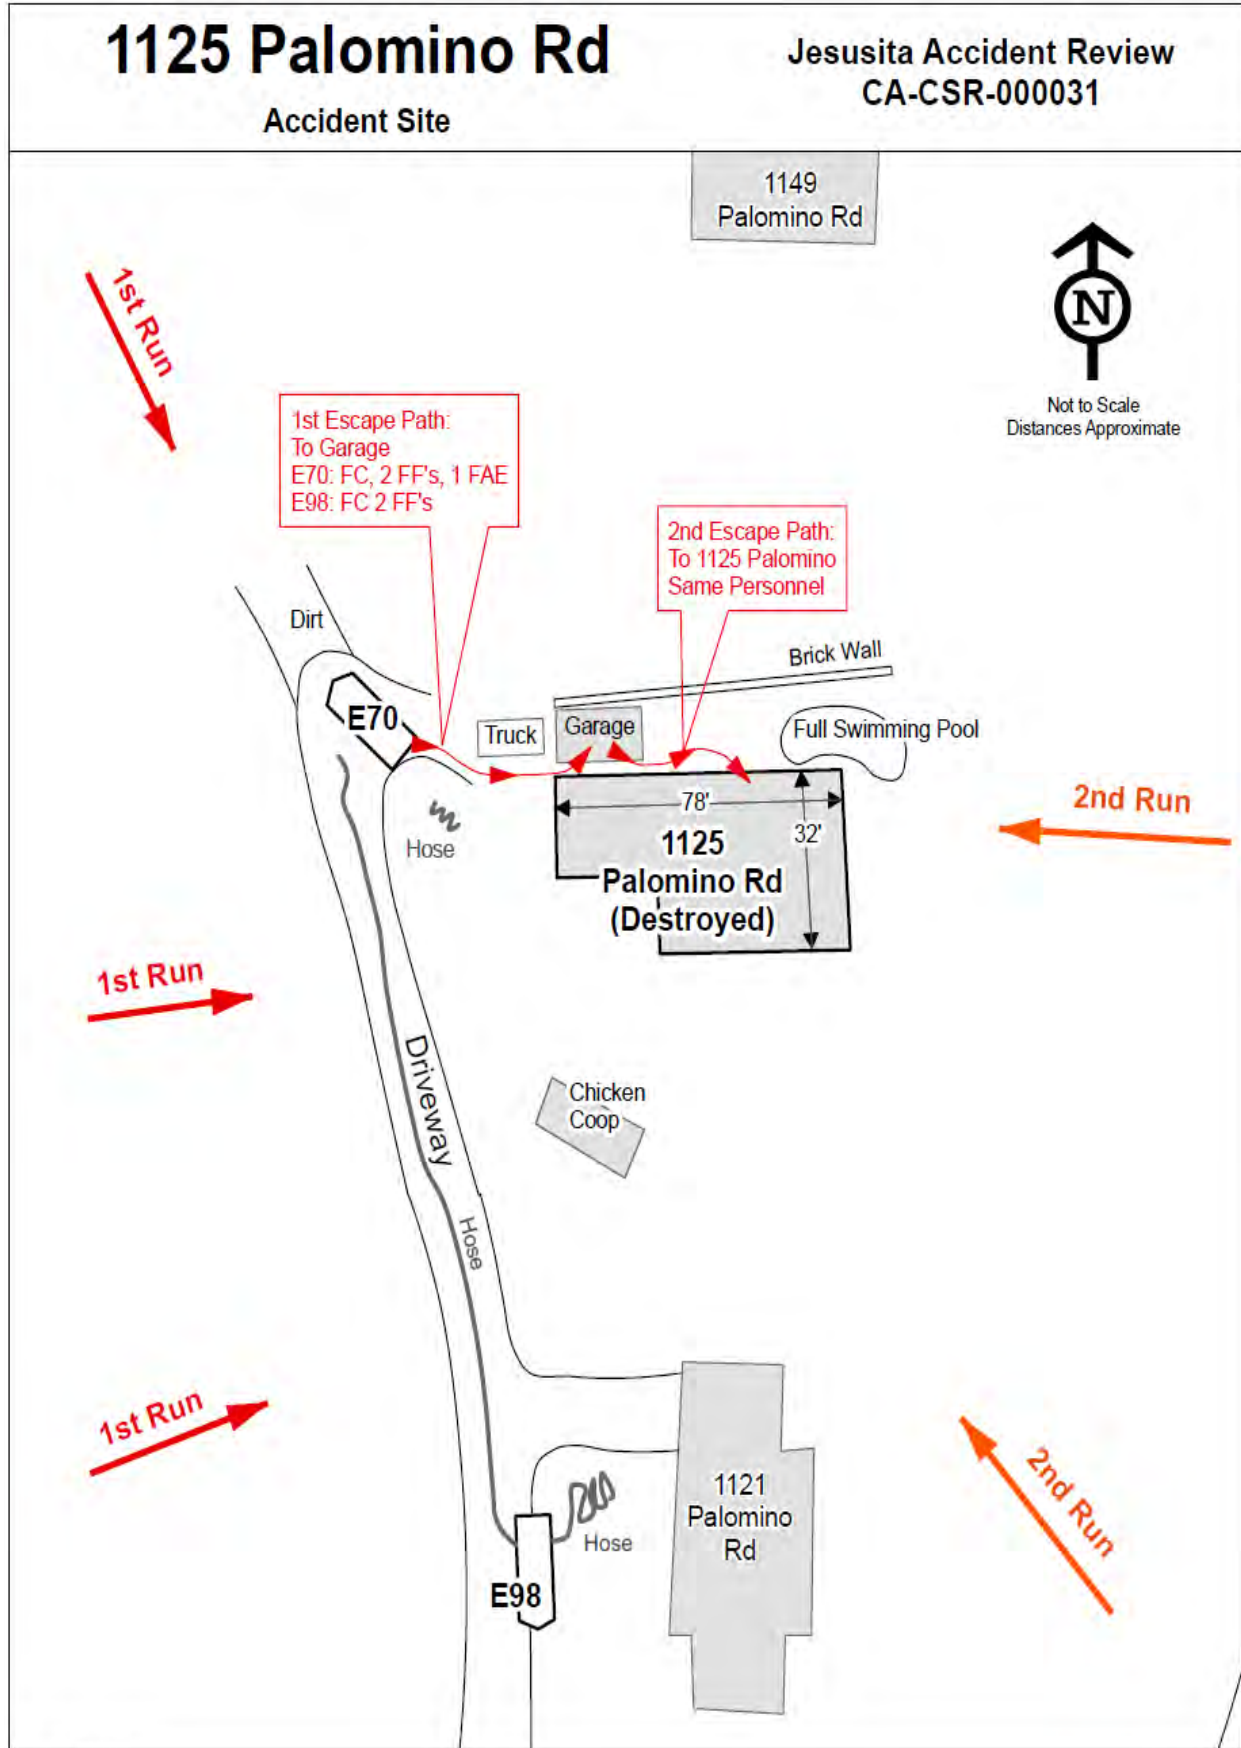
LAC E-70 had moderate fire damage to the complete front side of the vehicle, including cracks to both front windshields and the cab mounted light bar destroyed. Left side tires were damaged. The motor had stalled on the incident, and the crew discovered the air cleaner had burned. The engine was equipped with an ember screen on the motor air intake.
